The Activities of Informal Land Development Practices in Tudun Yan-Lihidda Settlement, Katsina State, Nigeria

Mustapha Muhammad

Department of Quantity Surveying, Hassan Usman Katsina Polytechnic, PMB 2052 Katsina, Nigeria

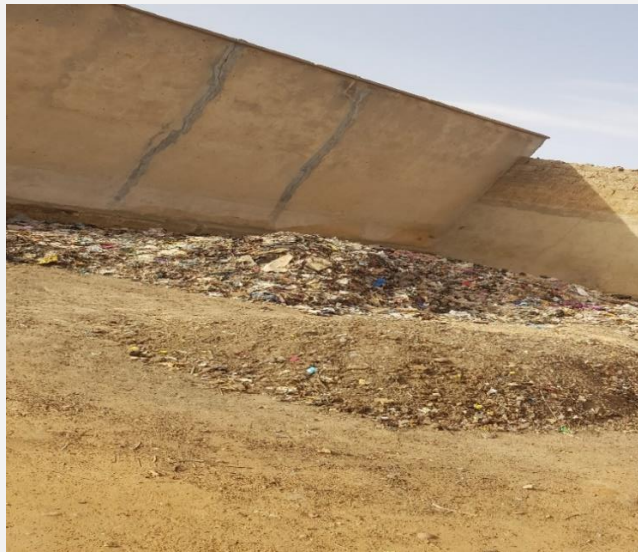
Another problem of informal land practice is the provision of sub-standards plots and it is because of the cheap coast of land associated with large drainage passing through the settlement, unplanned abattoir and other hazardous nature in the area. Traditionally, it is the use of single alignment/building line to take control where necessary. Precisely, it is very difficult in Tudun Yan-Lihidda to execute development control activities. undeveloped lands became the dispersal point of domestic waste from the houses because of lack of sanitation facilities. See [figure 2](#) Below.

Figure 2. Undeveloped Plot (6m * 9m) used for Indiscriminate Disposal in Tudun Yan-Lihidda, 2022

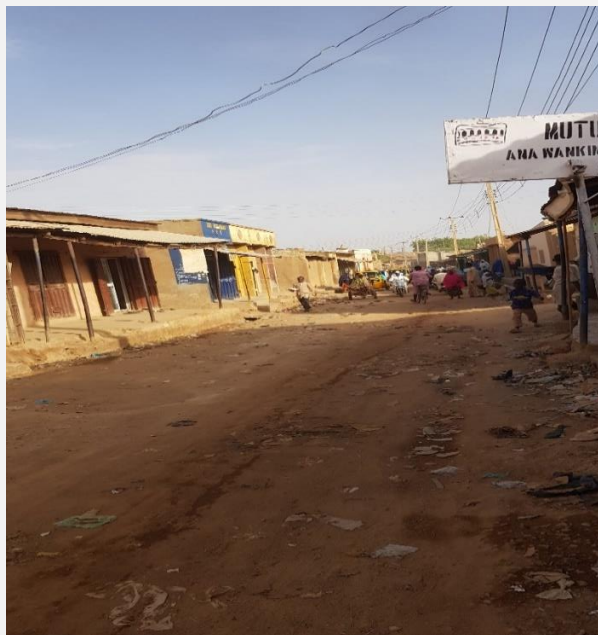
Setback is the minimum distance which a building or other structure must be set back from a street or road which is deemed to need protection (Kawu, 2012). Neighborhood setbacks are provided to ensure uniform appearance, installation of facilities and services such electricity, water pipeline supply and prevent houses from crowding adjacent structures or street (Kawu, 2012). The building of shops within the area is a competitive phenomenon to the people of the area. Conner shops are built along the roads with no setbacks for facilities. Although spontaneous, encroachment of the setbacks generates non-conformity in the area. Such is the situation here as shown by figure 3.

Figure 3. An Existing Major Road showing the domination of Conner Shops in Tudun Yan-Lihiddah Settlement, 2022

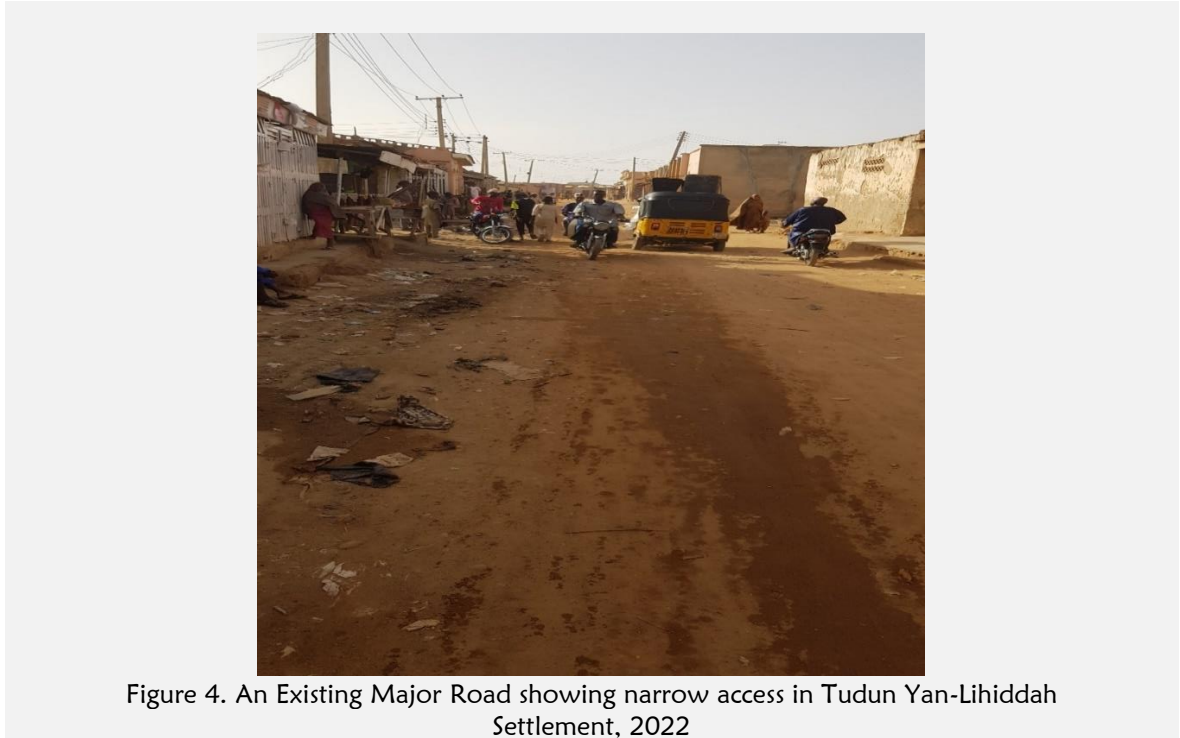
Popular new attractions or dozens of new building means more travel in the neighborhood. To cope, typically require large street, or road capacity for many residences (Mabogunje, 2008). The roads and streets are narrow below the required standards and causes congestion across the neighborhood (see figure 4).

Figure 4. An Existing Major Road showing narrow access in Tudun Yan-Lihiddah Settlement, 2022

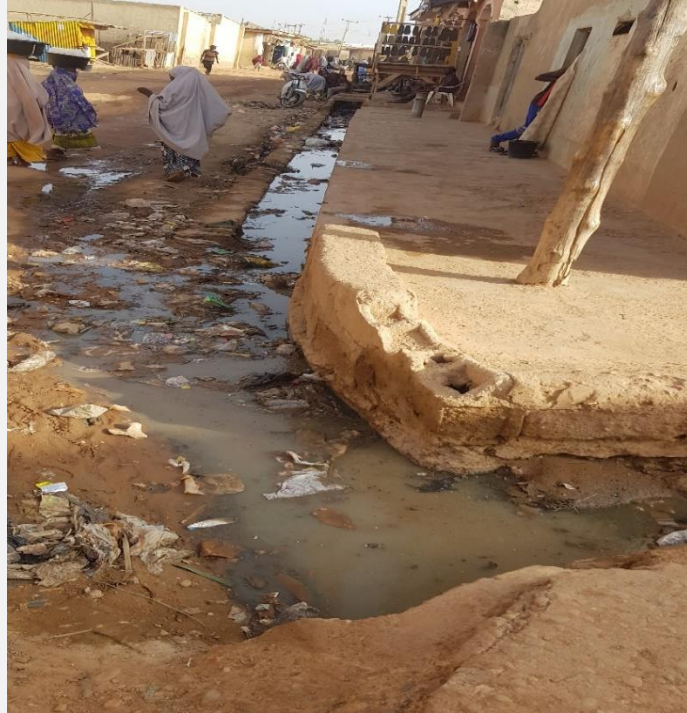
The roads and drainage infrastructure are also a problem of informal land practices in the area. The road is un-tarred and affected by erosion which leads to land degradation. Drainages are not uniformly constructed and aligned alongside the roads (see figure 5). Poor access roads and land degradation become the breeding area for mosquitoes and also contributed to the problems of illness.

Figure 5. An Existing Drainage Alongside the Major Road showing the condition of the drainage in Tudun Yan-Lihidda Settlement, 2022

1. The Urban Planning Board is to enforce and mitigate further activities of such informal practices in the Urban areas in the case of Tudun Yan-Lihidda and the Urban area as well.
2. The Urban Planning Board is also to sensitize and enlighten the public on the impacts of informal land practices through Media and all means of communication in the Urban area of Katsina State.
3. The lack or inadequate existing facilities such as school, health center, out-post, sanitation, in the area needs the attention of the Urban Planning Board to provide spaces for such facilities for better quality of life of the people.
4. Poor conditions of the drainages and roads need the call for the executive government to rehabilitate and construct where necessary.

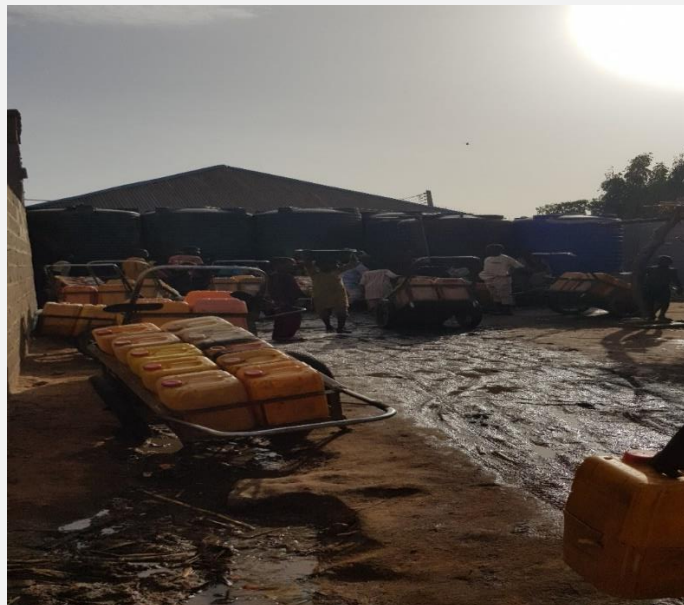
Local facilities in residential neighborhood play an important role towards the social and economic sustainability of the local residents. These facilities are basic components within a particular settlement that include recreational, health, educational, cemetery and other communal facilities (Mardiah, 2013). The only existing facility is electricity, cemetery of 1478m² as accessed and water tank which supply water to the settlement. The water tank is not function over a year due to lack of fund by the community. Large percentage of the resident's source water from private vendors as seen in figure 6.

Figure 6. An Existing Private Water Vendors in Tudun Yan-Lihiddah Settlement, 2022
