## Research Article

## Assessment of the Perennial Floods Affecting Residential Areas Along River Tille, Katsina Metropolitan, Katsina State, Nigeria

**Keywords:** Assessment, Perennial floods, River Tille, Katsina Metropolitan

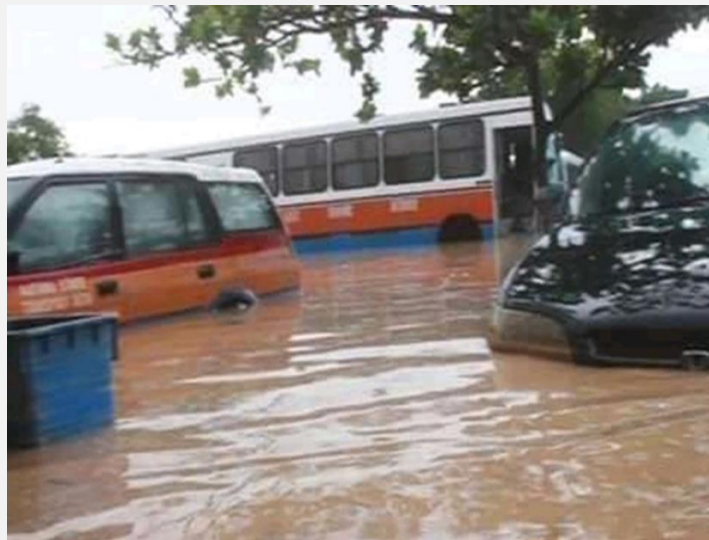
The most cited cause, by 30.00% of respondents, is heavy rainfall, which has been increasing annually, resulting in the river channel and other drainage systems being overwhelmed and leading to flooding. Climatic changes have made heavy rainfall more frequent at the onset of the rainy season, contributing significantly to flooding incidents, such as the one on July 20th, 2020, that affected the KTSTA garage at Kofar Guga ([Figure 2](#)). Data from Katsina State Emergency Management Agency ([KATSEMA, 2022](#)) shows that heavy rains leading to flooding in 2022 occurred mainly in July and August in Katsina Metropolitan. This aligns with findings by [Saleh & Inkani \(2024\)](#), who documented a corresponding increase in average annual rainfall in Katsina LGA, predicting continued extreme weather events like flooding.

Figure 2. Heavy rainfall causing flooding at KTSTA garage at Kofar Guga on July 20th 2020.

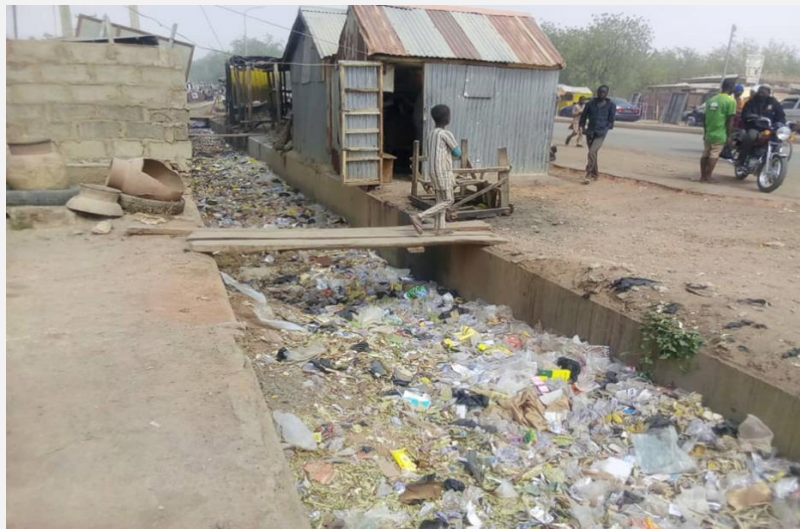
Dumping waste materials into stormwater drainages is identified as a significant factor contributing to flooding, with 16.66% of respondents acknowledging this issue. The practice of disposing waste directly into the drainage systems by traders, food vendors, tea sellers, and mechanics, particularly in front of the Kofar Guga motor park, severely obstructs the flow of rainwater. This blockage results in flooding during the initial rainfall events of the season. Reports indicate that individuals also use wheelbarrows to deposit waste into the stormwater drainages, exacerbating the problem. Despite complaints from motor park officials to the Katsina State Environmental Protection Agency (KATSEPA) for waste clearance, the response has been inadequate. This scenario aligns with findings by Mokuolo et al. (2022), highlighting the significant role of solid waste in causing persistent urban flooding in Isale Koko, Ilorin East LGA of Kwara State, Nigeria.

The issue of waste in the stormwater drainage, a visual testament to this problem, underscores the need for more effective waste management practices and public awareness campaigns to mitigate the risks of flooding. The waste dumped inside the storm water drainage can be seen in Figure 3.

Figure 3. Waste Materials dumped inside a storm drainage in front of Kofar Guga Motor Park.

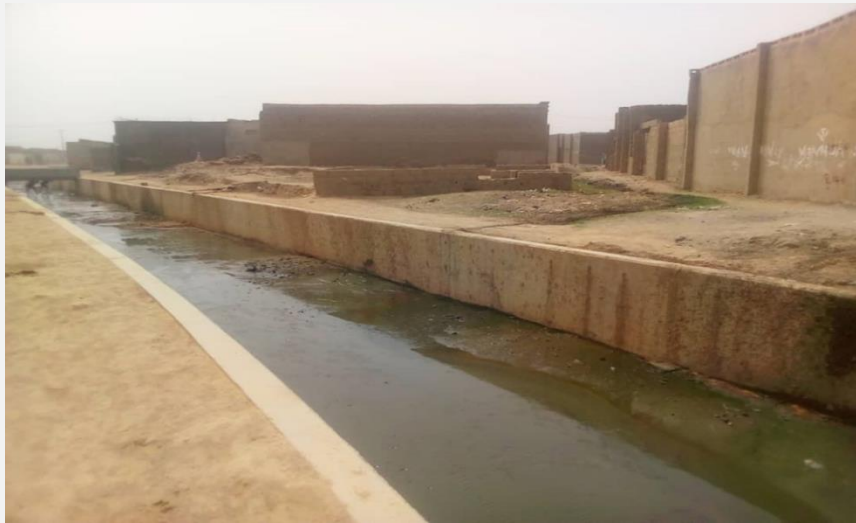
The project encompasses constructing an 11-km, 5-meter-wide concrete-lined drainage along River Tille. During a visit on September 23, 2020, the State Governor directed the project manager to implement several measures, including:

Figure 5 below shows a section of the constructed drainage at Tudun Yanlihidda residential area.

Figure 5. A section of the river converted to storm water drainage for flood control constructed by Katsina State Government from 2020 – 2021.

(iii) *Lack of Vegetation:* Contrary to directives from the State Governor, no trees or other vegetation were planted alongside the storm drainage. The absence of this vegetation left areas that could have served as flood plains for overflow unmitigated.
